Bollettino Tecnico / Technical Bulletin

TUTTI I MODELLI DI SUPERAUTOMATICHE (INCLUDE MACCHINE DA INCASSO)**ALL FACM MODELS (INCLUDING BUILT-IN COFFEE MACHINES)**

Data / Date: 01/07/2021

ENGLISH**SUBJECT: Solution to the Occurrence of the Message “INSERT INFUSER ASSEMBLY” on Fully Automatic Coffee Machines**

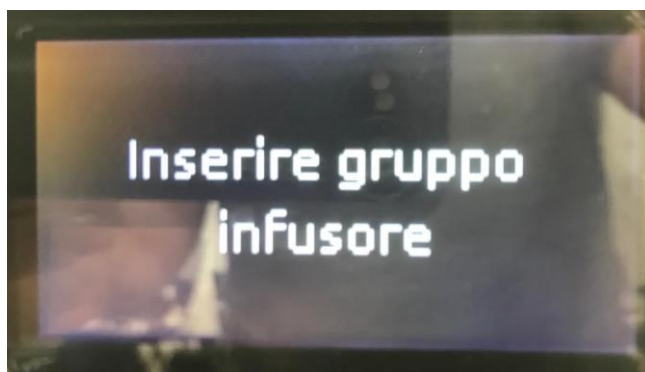
"Inserire Gruppo Infusore" su Macchine da Caffè con Display

CAUSA DEL PROBLEMA: La comparsa del messaggio "Inserire Gruppo Infusore" anche quando l'infusore è fisicamente presente nella macchina è solitamente causato da un degrado della lettura della quota massima da parte dell'elettronica della macchina da caffè.

SOLUZIONE: Per eliminare l'occorrenza del messaggio "Inserire Gruppo Infusore" si raccomanda di eseguire l'operazione di **RESET ENCODER** per il ripristino del valore corretto di quota massima dell'infusore seguendo la relativa procedura presente nella scheda tecnica specifica del modello macchina da caffè superautomatica in cui il problema si manifesta.

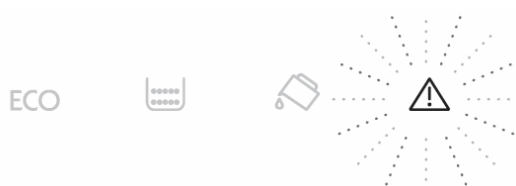
"Inserire Gruppo Infusore" su Macchine da Caffè senza Display

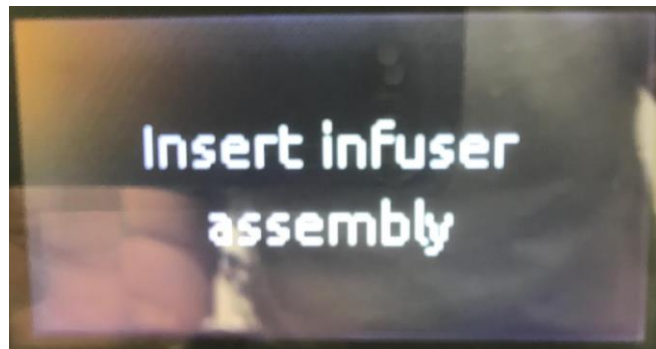
“Insert Infuser Assembly” on Coffee Machines with Display

CAUSE OF THE PROBLEM: The appearance of the message “**Insert Infuser Assembly**” even when the infuser is physically installed in the machine is usually caused by a degradation of the reading of the maximum height by the electronics of the coffee machine.

SOLUTION: To eliminate the occurrence of the message “**Insert Infuser Assembly**” it is recommended to perform the **ENCODER RESET** procedure to restore the correct value of the maximum height of the infuser, by following the dedicated procedure reported in the technical data sheet for the specific model of fully automatic coffee machine in which the problem occurs.

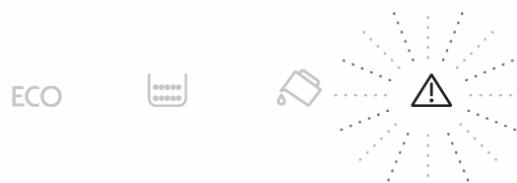
“Insert Infuser Assembly” on Coffee Machines without Display
